December 1976

THREE RIVERS, OTERO COUNTY, NEW MEXICO

A PROJECT OF EXCAVATION, STABILIZATION, AND
INTERPRETATION OF A PREHISTORIC VILLAGE

A REPORT PREPARED FOR THE U.S. DEPARTMENT OF THE INTERIOR, BUREAU
OF LAND MANAGEMENT, LAS CRUCES DISTRICT, by the Cultural Resources
Management Division of the Department of Sociology and Anthropology,
New Mexico State University, Las Cruces, New Mexico.

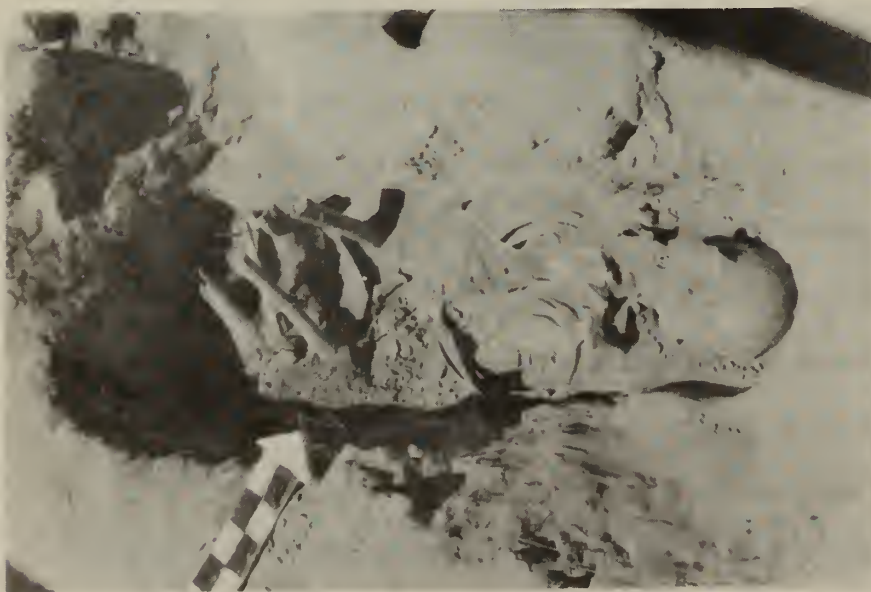
PHOTO 27. Burial - Adult - Adobe Structure

The third burial, Specimen #68 was found in the south rectangular room in the adobe structure. It was found beneath the floor in the northeast corner of the room. It was flexed, face up.

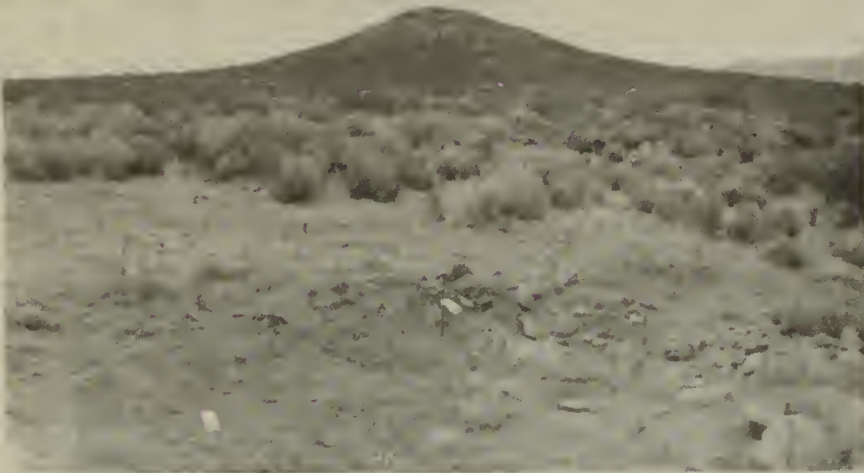
PHOTO 1. Masonry Structure - surface indication

pretation of the surface remains were the same as that of Marshal. We felt that it was a masonry surface pueblo. A photograph (Photo 1.) is included to show the structure after the vegetation was cleared and before excavation was begun.

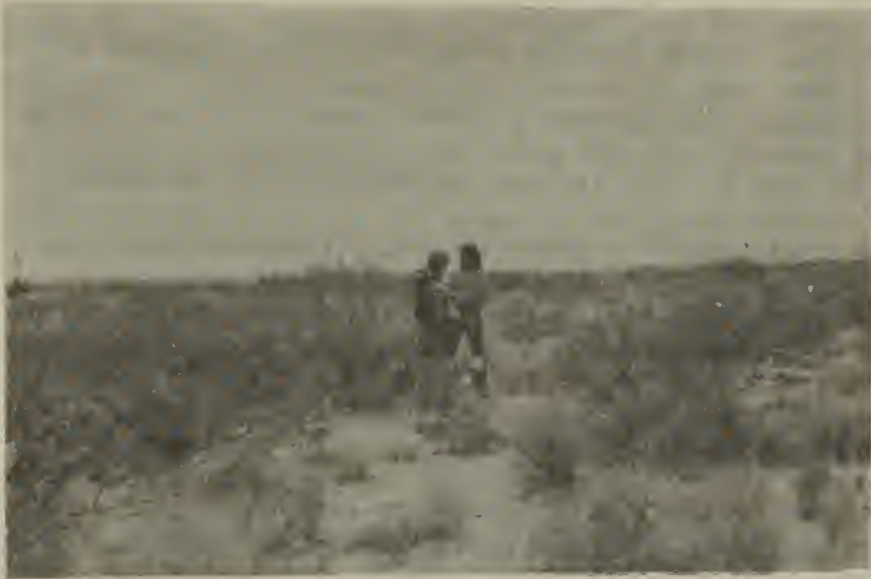
PHOTO 3. Magnetic Survey - Area of Adobe Structure

There were some depressions and potholes in the area around Provenience One that we thought might be pithouses. Tony Preslar, a geophysicist and archaeologist, explored these depressions and other likely areas with a hydrogen proton magnetometer. He was able to identify six magnetic anomalies which appeared as negative magnetic susceptibility profiles.

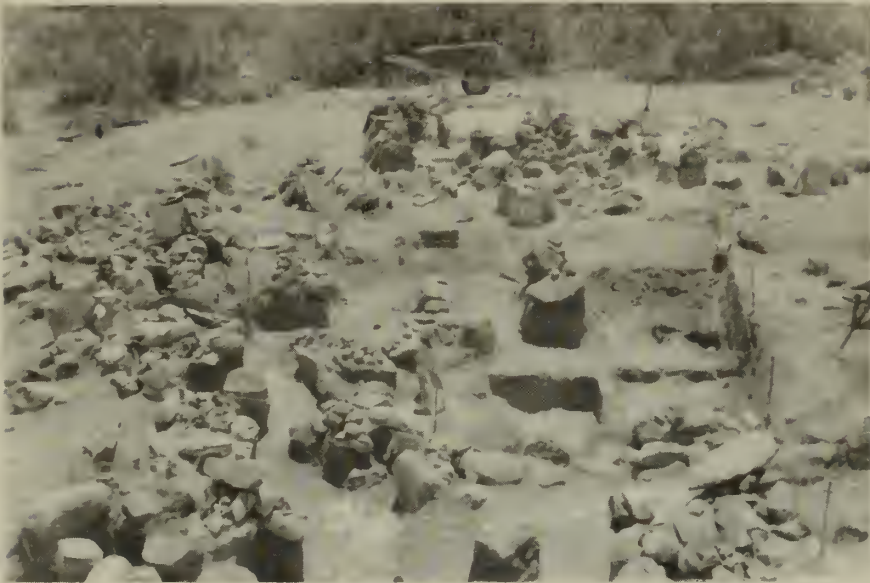
PHOTO 4. Masonry Structure - Work in progress

Before excavation, Area A appeared to be multi-room surface structure of stone masonry. Part of the structure had been damaged by pothunters, but much of it remained undisturbed. However, excavation showed that it was a large, single room semi-subterranean structure utilizing several construction techniques. Photo 4 shows the rock as it was found. Photo 5 shows the structure as it was cleared and ready for reconstruction.

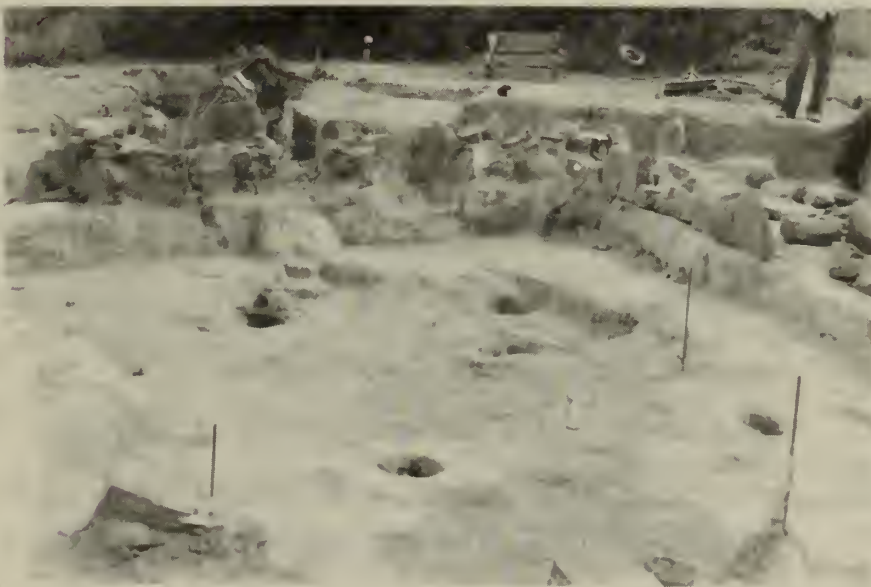
PHOTO 5. Masonry Structure - South Wall and Step

Construction began by excavating a large pit into the gypsum. The level floor ranged from 12 inches to 18 inches deep, depending on the elevation of the surrounding ground surface. Loose surface soil was scraped back from the edge of the pit and a rubble wall of roughly coursed rocks (cobbles and clasts) was built to a height of about two feet on the edge of the pit. Although much of the wall had collapsed, enough of the south wall remained to reconstruct it. The wall was a composite wall with an uncoursed rubble and mortar core between the faces. Occasional oblong blocks laid perpendicular to the axis helped bond the two faces. At the time of excavation, portions of the wall stood from 12 to 22 inches high. The rock recovered from the excavation was used in reconstruction, but there was only enough to raise the entire wall to a height of about two feet. Because of the size of the rock used, the degree of slope and the nature of the local erosional pattern, it is not likely that much rock was washed away. A number of possibilities remain. First, some of the rock may have been salvaged for use in later structures. This is very possible, but there is no real way to assess the probability. Second, the upper wall may have been made of coursed adobe. There was no evidence of much adobe in the house fill, but if they were using the local gypsum soil, it would not be distinguishable in the fill. Third, and most likely, is that the sides of the roof were brought down to the top of the rock wall in the manner of the early pit houses, giving what were essentially steeply slanting upper walls (See Illustrations).

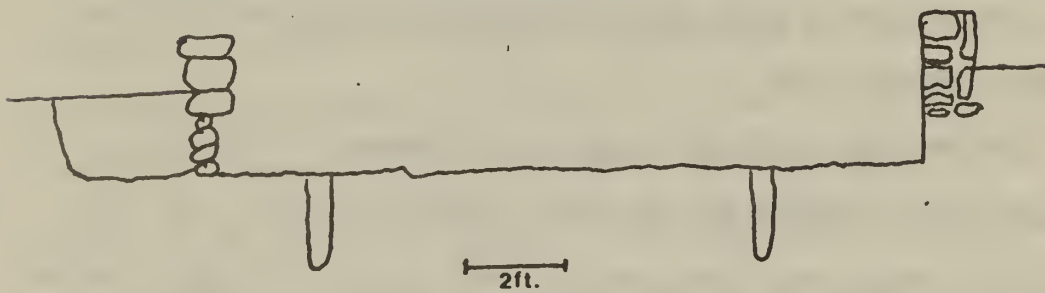
ILLUSTRATION 3

Masonry Structure - Feature A

Two and four post roof supports are common; this structure had four post supports and two small additional posts. The Temporal Site had a south step and four main posts; it is also similar in that the roof was burned. Abajo Del Cruz has a masonry room utilizing upright stone foundations and horizontal upper courses. It also had some rubble fill.

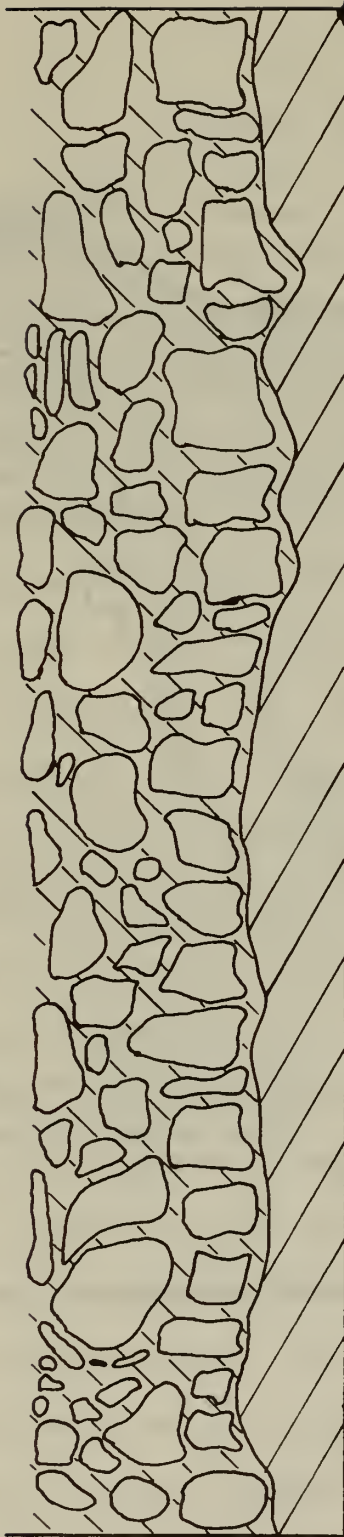
LA 4921

Stone Masonry Structure
Profile, East Wall

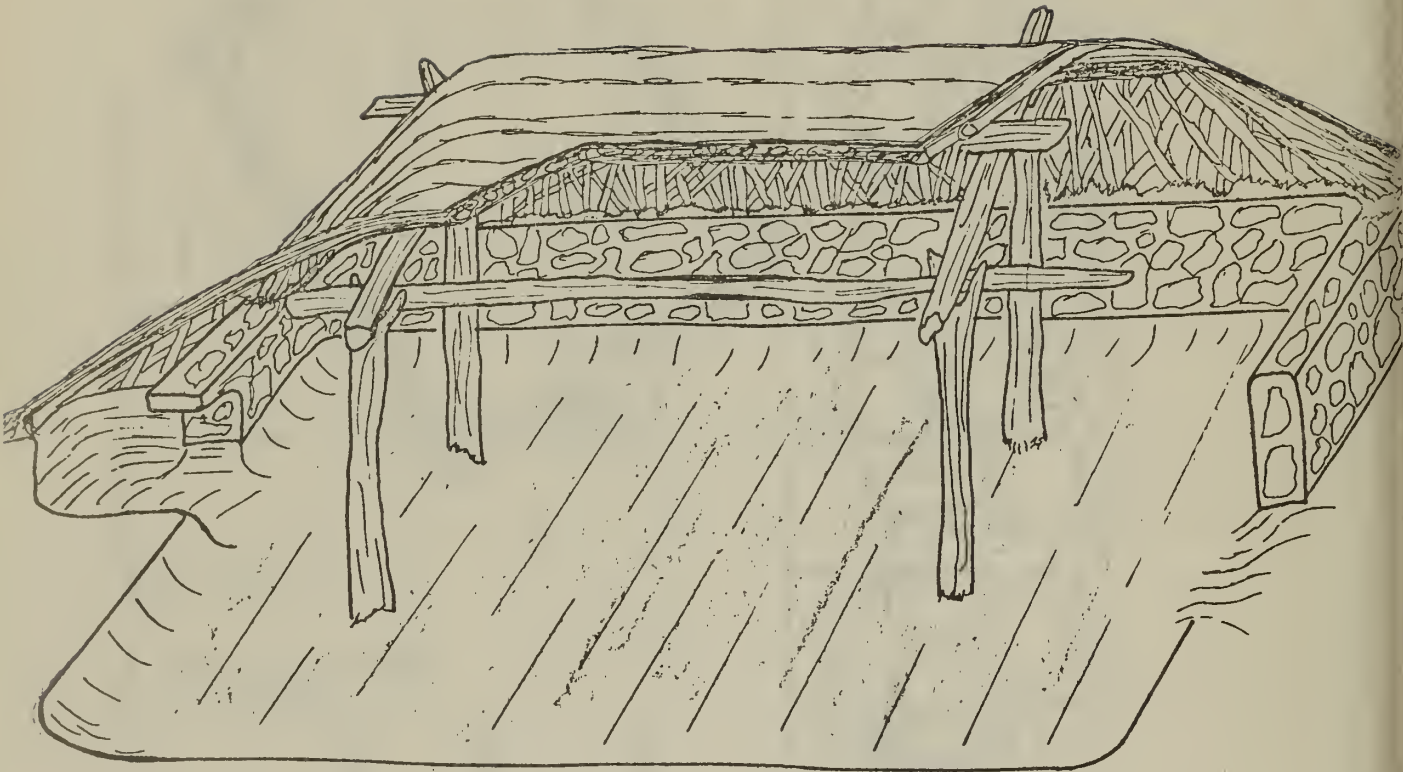
LA 4921

Cutaway View, Reconstruction
Stone Masonry Structure

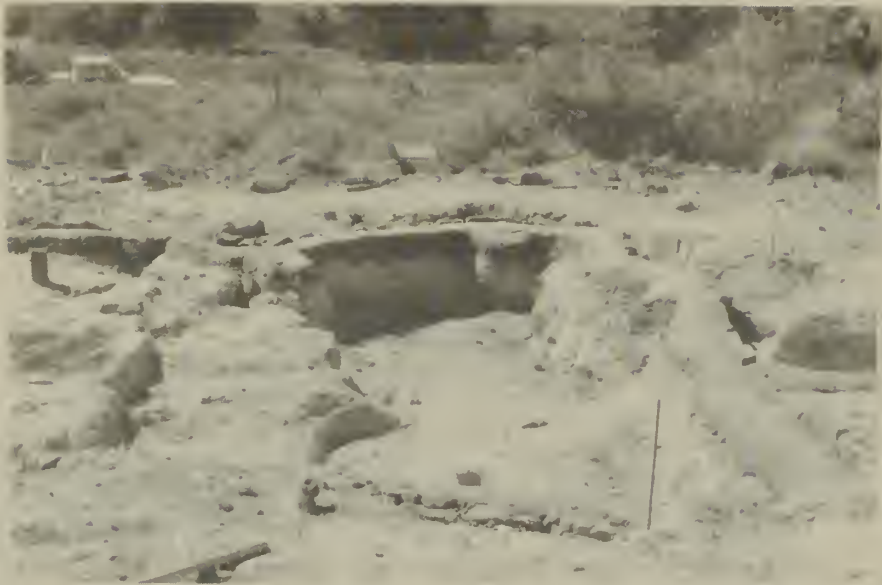
PHOTO 6. Adobe Structure - Work in Progress

Floor features are identified in the legend with the room maps (Illustration 6). All of the rooms contain hearths, and all probably were used as living rooms. Illustration 7 shows a cross section of the stratigraphy of the fill, and Illustration 8 is an artist's reconstruction. Photos 6 and 7 show work in progress.

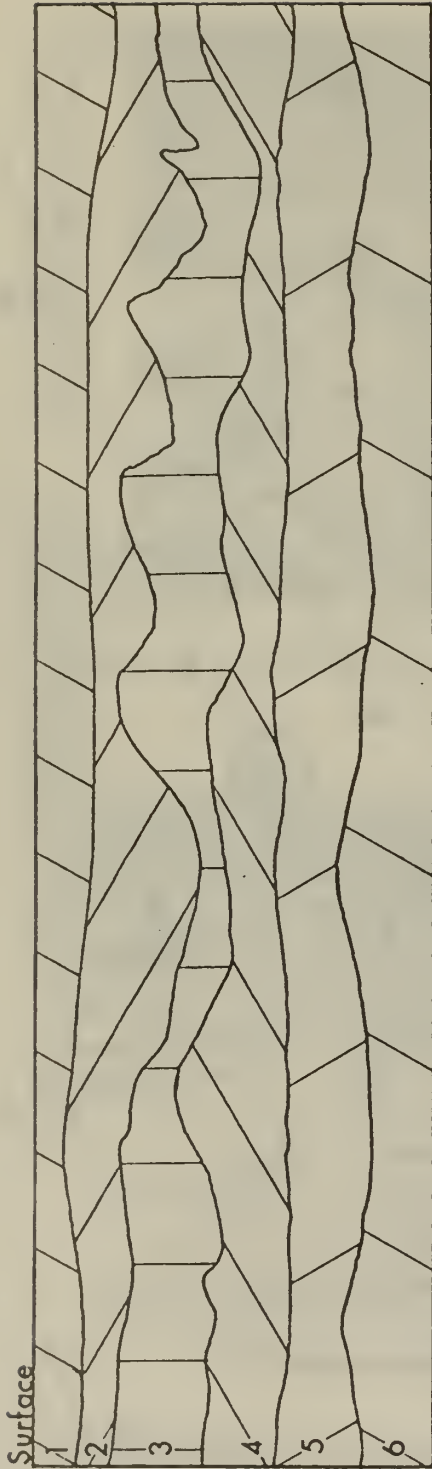
1. Reddish loamy sand - aeolian deposition
2. Hardpacked sand and gypsum - small amount of charcoal
3. Hardpacked gravel and gypsum - alluvium deposition - light root system
4. Softpacked gypsum and loamy sand - large amount of small roots
5. Floor fill
6. Gypsum - sterile

Feature 6 - Fill Stratification

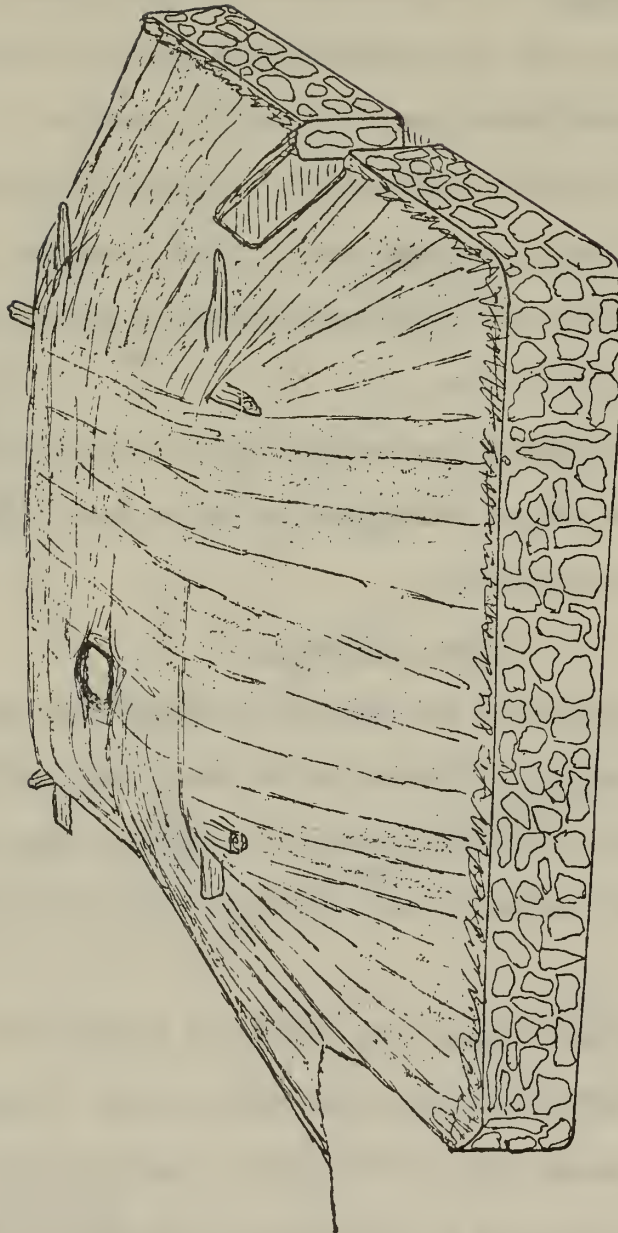
LA 4921

After the room was cleared and defined we started the reconstruction by laying the bottom course of stone. Some of these stones were set on edge on the sterile gypsum ledge; others were set in holes cut to the shape of the stone. Both an inner and an outer face were laid, occasionally a stone was

Artist's Reconstruction
Stone Masonry Structure

The mortar we used was a mixture of clear gypsum soil backfill (2 parts), sharp sand (1 part), lime (1 part) and water with 4 oz. of cement bond added per gallon. After testing the existing mortar mixture it was found to foam under hydrochloric acid and it was therefore determined that some form of calcium carbonate was probably used as a binder with the gypsum. Because it would have been difficult and time consuming to collect sand, it was purchased locally from a cement company. The cement bond was used to give strength to the mortar mix and to protect it from water damage. Hydroplastic cement was used on the last stone course with lengths of steel reinforcing bar to form a structurally stronger bond and to protect against the elements and human traffic. (Illustration 12).

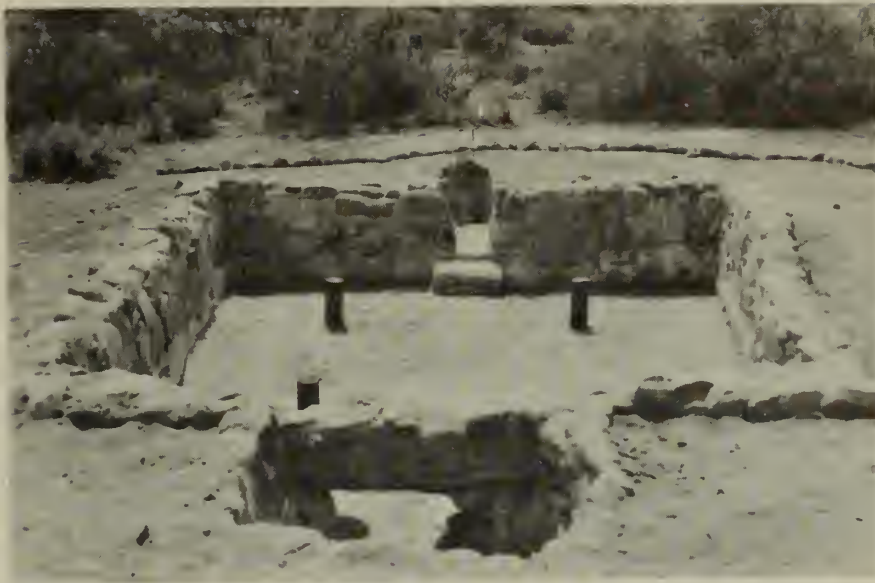
PHOTO 10. Masonry Structure - Reconstructed

The four primary postholes were plugged with creosote posts and allowed to stand above the floor, thereby giving an indication of the structure to visitors. The floor was leveled with back-fill, sand and a little lime. This was necessary because the excavation was taken to sterile soil and there was much rodent burrowing at the floor level. The entrance step was capped with hydroplastic cement and reinforced with steel reinforcing rod. The entire structure was sprayed with masonriseal. This product is a water miscible, siloxane anti-capillary used to prevent erosion and aid in abrasion contact. The floor was sprayed two feet out from the walls, the remainder being left to absorb and drain water.

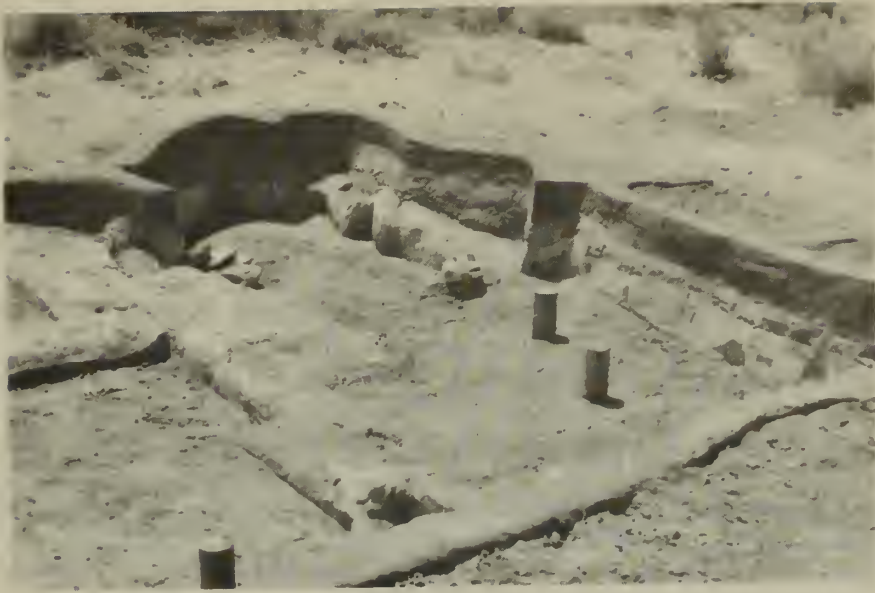
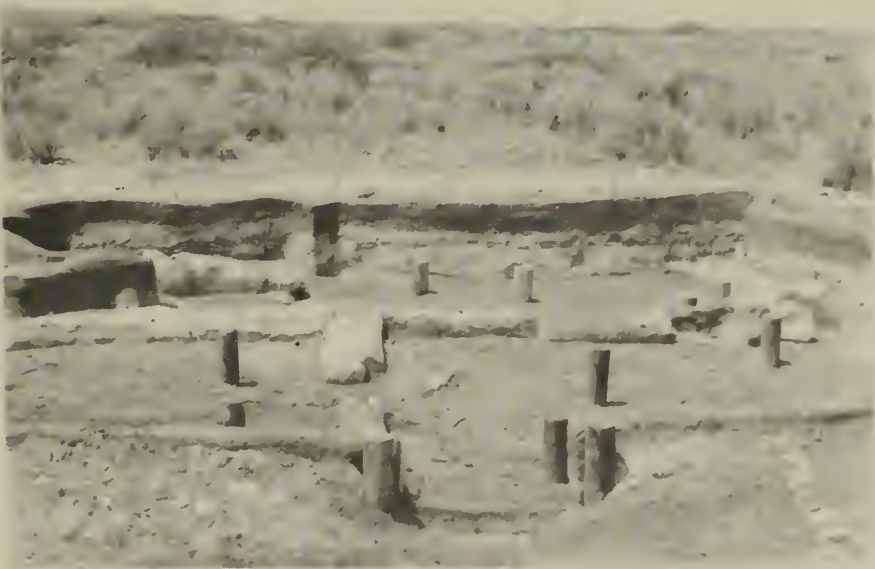
PHOTO 11. Adobe Structure - Reconstructed

After clearing and defining the two rectangular rooms and the contiguous pit room, we started the reconstruction by laying the first course of puddled adobe. This first course was found to contain too much clay and had to be removed. The starting ratio was 4 parts clean backfill and 1 part clay; however this was changed to 5 parts backfill and 1 part clay. Cement bond was used in the first and second course but was too expensive to repurchase. A small amount of plasterers' lime was added at the rate of two shovel-fulls for every wheelbarrow load of clay. The mixture was prepared by making large "volcanos" that were filled with water and mixed with hoes and shovels to a doughy consistency. As there was insufficient time and manpower to gather the adobe at the site, clay was purchased from an adobe company at La Luz, New Mexico.

The walls were rebuilt to a height slightly above the present grade. We were not able to determine the height of the walls, but we did not feel that they were as tall as the top of the roof. It is likely that the walls supported beams radiating from the center four-post superstructure. The postholes were plugged with creosoted wood posts and allowed to stand above the floor thereby giving an indication of the structure to visitors. The floor was leveled with backfill and sand. The entrance was protected by two posts at each side and the area graded to prevent water from washing in. After two weeks of curing , the entire structure was sprayed with masonriseal two feet out from the walls, the remainder being left to absorb and drain water. (See Illustration 8).

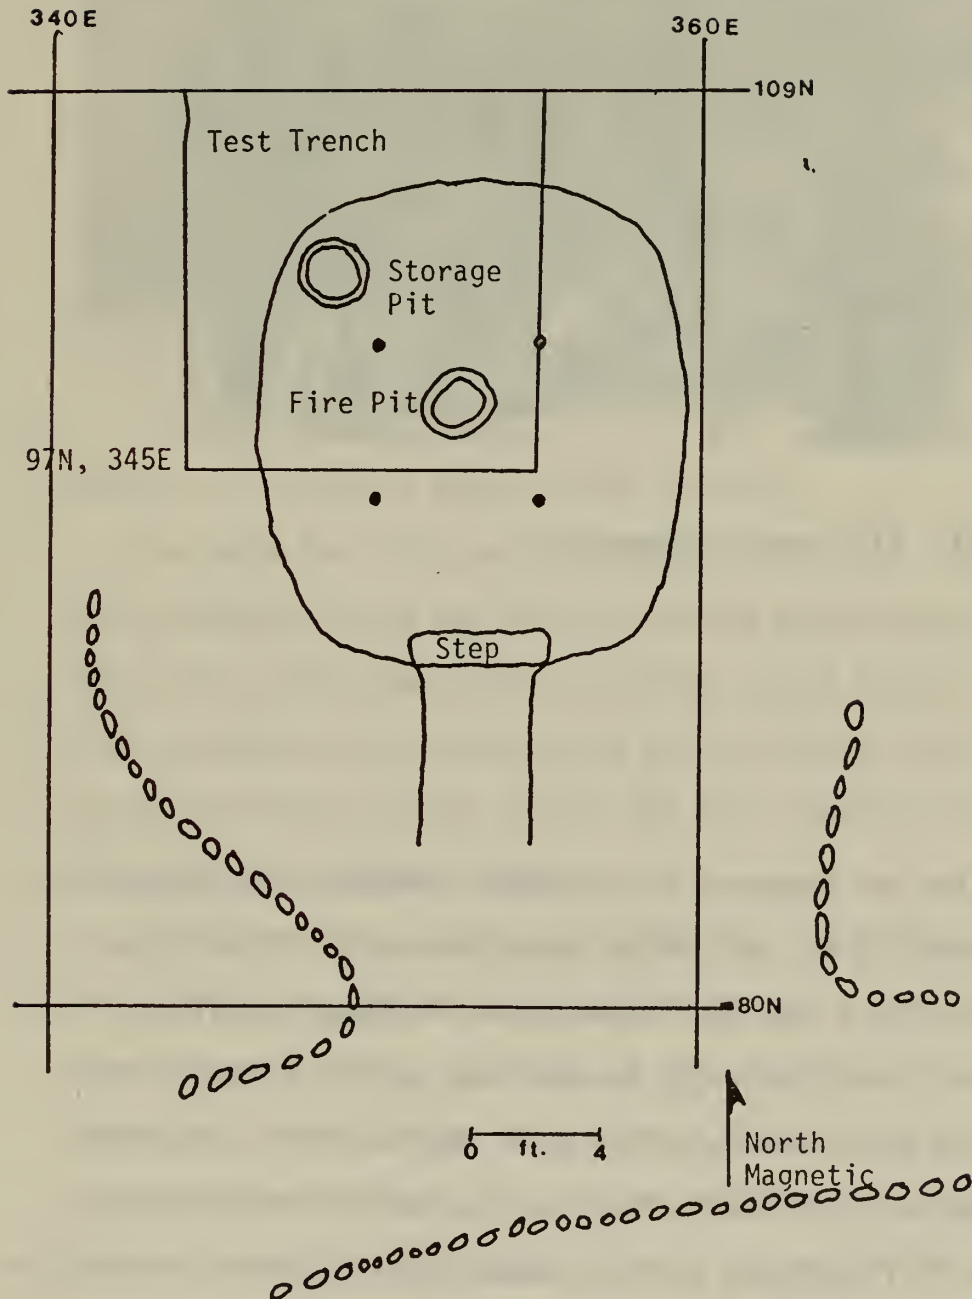
ILLUSTRATION 13.
Pithouse Floor Plan

We excavated a squarish hole with round corners about 15 feet 7 inches north/south by 12 feet east/west and 30 inches deep. A ramp entrance was excavated with southern orientation; there is a step into the ramp and a step at the end of the ramp into the room. Four postholes were dug and forked posts installed and levelled. Beams were placed between the forks and others were laid over these to form a smoke hole and form a support for the beams radiating to the circumference of the pit. Long poles or beams were set in holes dug around the exterior top of the pit and rested against the center framework; others were laid in place to fill out the framework. See Illustration 13.

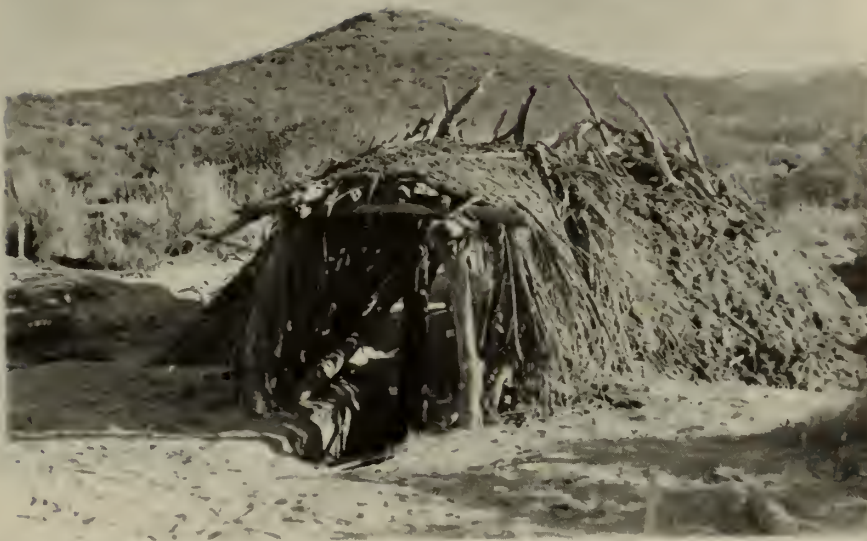
PHOTO 14. Pit House - Brush and Mud Covering

After the framework was completed the adobe was prepared in same manner as for the puddled adobe structure. Tules or cattails were laid over the framework, and the adobe was placed over them, thus preventing the mud from falling through. The adobe was laid from the bottom up on the exterior. As a course of adobe was laid, small sticks were poked into the course to further fill the holes in the framework and hold the tules in place. Some adobe was placed around the base of the framework on the interior to hold the posts in place and to add structural strength.

The adobe was first applied approximately three inches thick; another coating two inches thick was added two days later. Additional patching was done as shrinkage cracks appeared. After the adobe had a chance to set up to a plastic state it was pounded with round cobbles to bind the adobe together and to obliterate the shrinkage cracks.

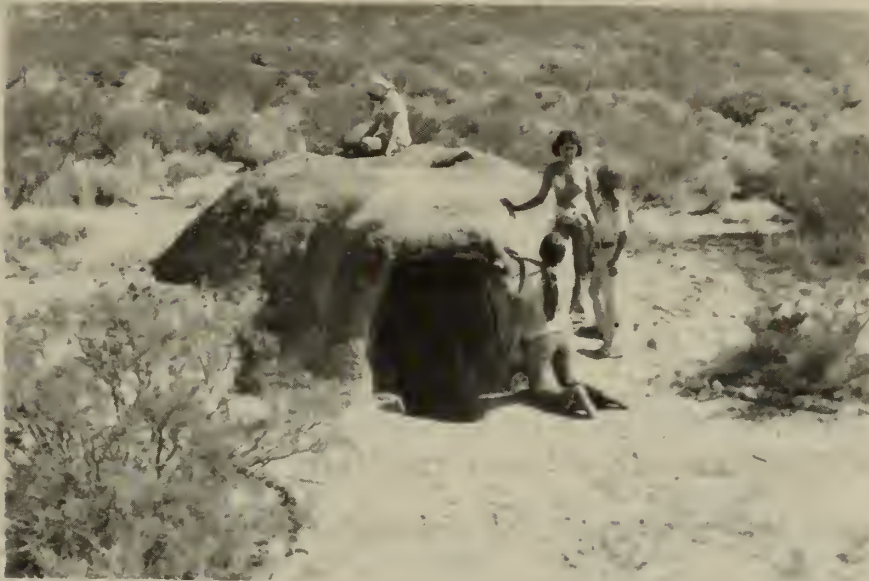
PHOTO 15. Pithouse - Reconstructed

Loose sticks and tules were pulled from the interior and the interior was sprayed with penachlorophenol, a wood preservative and insect toxin. A portion of the previously excavated storage pit extended below the pit house floor in the northwest corner of the pit house. This pit was modified and plastered and became a storage pit for the pit house. We constructed a small fire pit in the center of the floor and lined it with adobe.

The greatest difficulty in preserving the reconstructed site is water damage. For this reason sufficient drainage must be maintained around and within the structures. It would be advisable to roof or in some way cover the two open structures.

It will be necessary to review the condition of the structures yearly. Cracks and loose rocks should be repaired whenever necessary. The adobe and mortar should be sprayed with masonriseal (or similar substitute) once a year or more often as necessary.

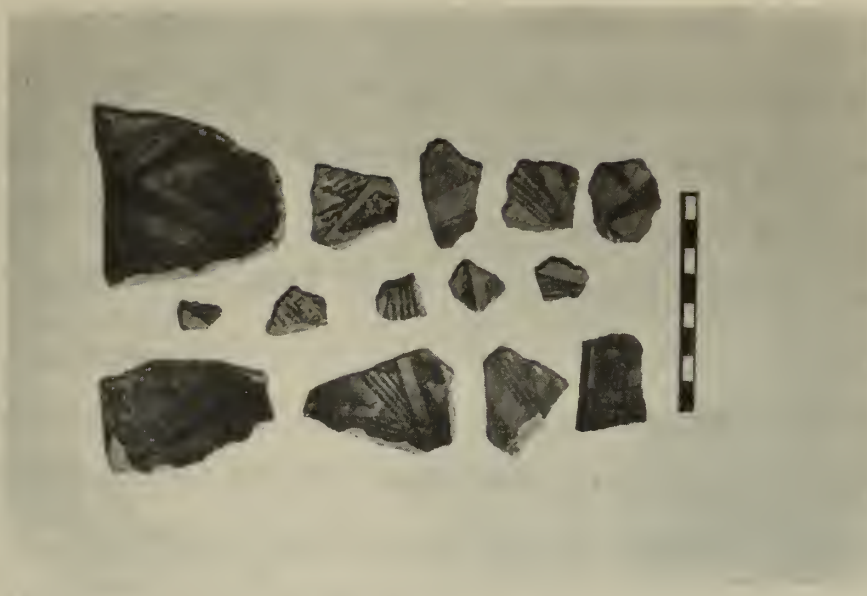
PHOTO 16. Pinedale Polychrome Sherds

Vessel Forms: Bowls. The rims are beveled toward the inside.

Comments: This type of White Mountain Redware is probably Pinedale Polychrome as described by Carlson (1970).

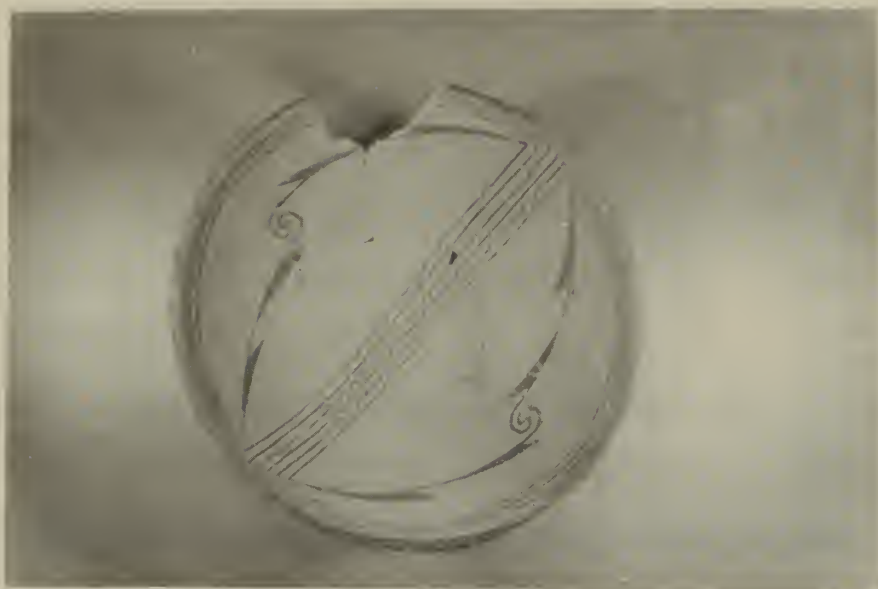
PHOTO 17. Three Rivers Red-on-Terracotta Bowl

1. Three (3) Three Rivers Red-on-Terracotta Bowls (one of these is illustrated -- see PHOTO 17.).

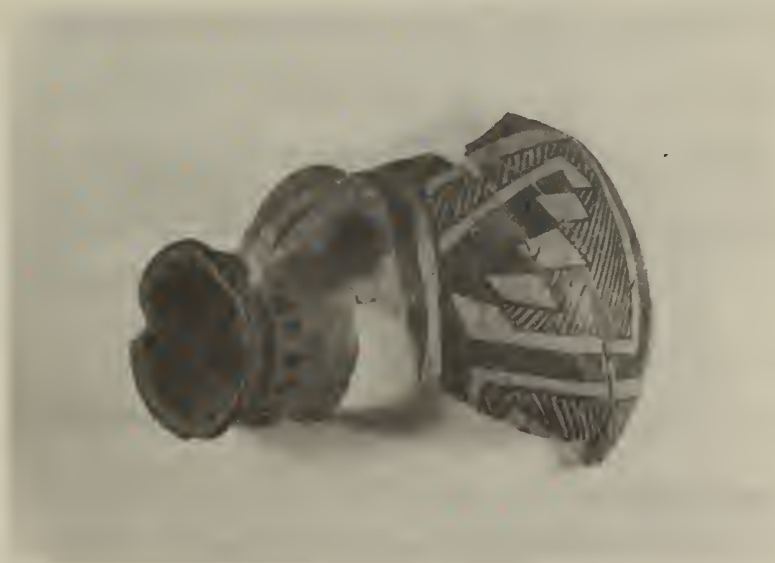
PHOTO 18. Chupadero Black-on-White jar portion

2. Four Chupadero Jars (a portion of one of these jars is illustrated -- see PHOTO 18.).

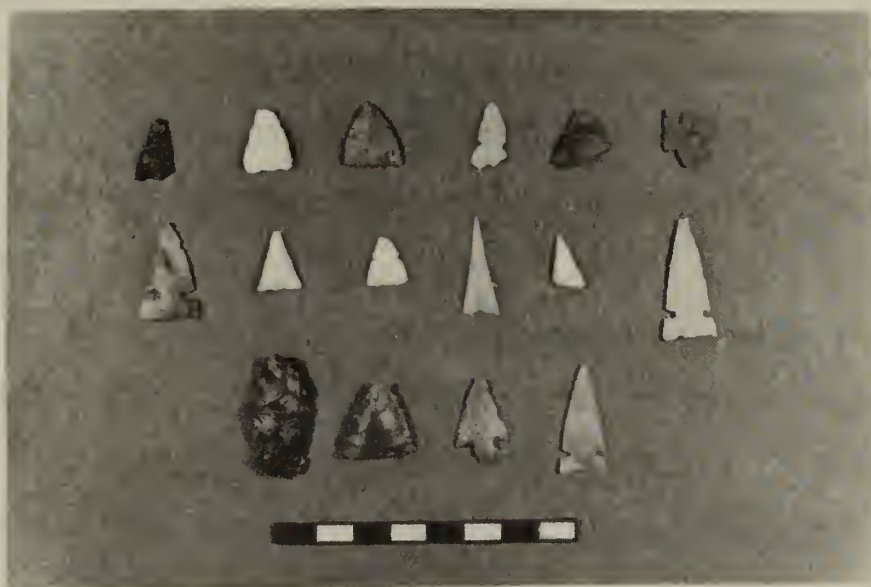
PHOTO 19. Projectile Points -- Area A - Masonry Structure

Over 125 projectile points and drills (including fragments) were recovered from this site. To give an idea of the types of projectile points found, a representative sample was chosen and photographed. The projectile points are divided into the three separate living areas in these photos (Photos 19, 20 and 21).

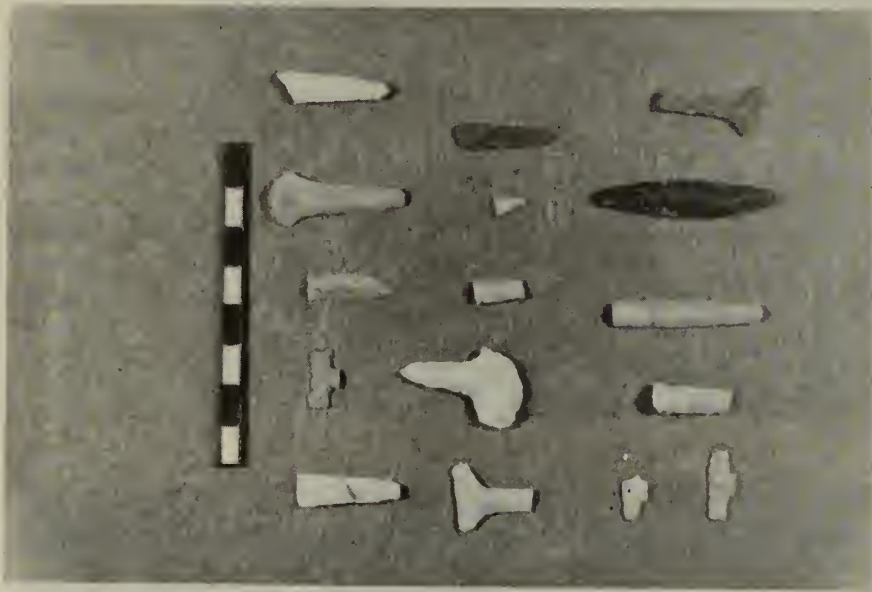
PHOTO 22. Drills

The drills recovered have also been photographed; however, they have not been divided into the separate living areas (Photo 22).

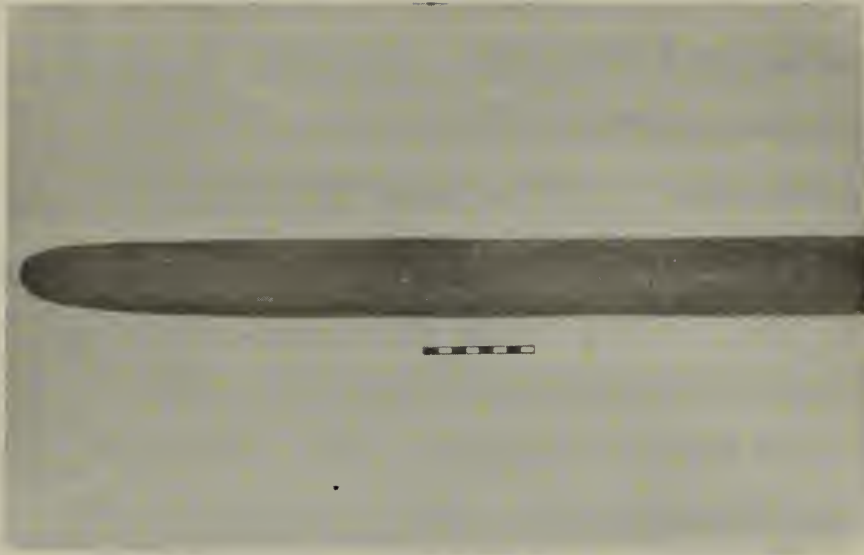
PHOTO 23. Schist Shaft

Schist Shaft -- One green schist shaft was recovered from this excavation. The schist shaft is broken into 4 separate pieces. Length of the shaft is 61.6 cm. The breaks are very clean and even with little attrition as if the bar was either intentionally broken or remained in place where it was broken. The circumference at the base is 15.2 cm. This tapers only slightly over the length until it reaches the tip where it decreases considerably to a 8.3 cm circumference. The shaft is very smooth and exceptionally well made. The underneath side of the base has

been ground to form an indentation. Slight striations are apparent over the entire length of the bar. These appear to be due to manufacture rather than use. The tip is slightly battered. Due to the extremely fragile nature of schist and the amount of time required for the manufacture of such a shaft it seems unlikely that the tip was

Three burials were recovered. The first, Specimen #15 was found at the bottom of the storage pit. Photo 9 in the architectural section shows the location where the skeleton was found. The schist bar (Photo 23) was immediately above it. This specimen consists of a partial skull, the proximal end and head of one femur, and miscellaneous chips. The specimen was too badly decomposed to be of any analytic value. The second burial, Specimen #61 was found in a hallowed out section of the north wall of the contiguous pit room. It was found covered by a Three Rivers Red-on-Terracotta bowl, see Photo 17 . Specimen #61 is the partial skeleton of an infant 18-24 months of age. It consists of two fragmentary femurs; a fragmentary fibula; a fragmentary humerus; a complete left clavicle measuring 9.2cm.; and the distal end of the right clavicle. Eight deciduous teeth were found in association: two incisors, two canines, four molars upper and lower first and second molars. None of the roots had ossified. Also some small skull and pelvic fragments and miscellaneous chips were recovered.

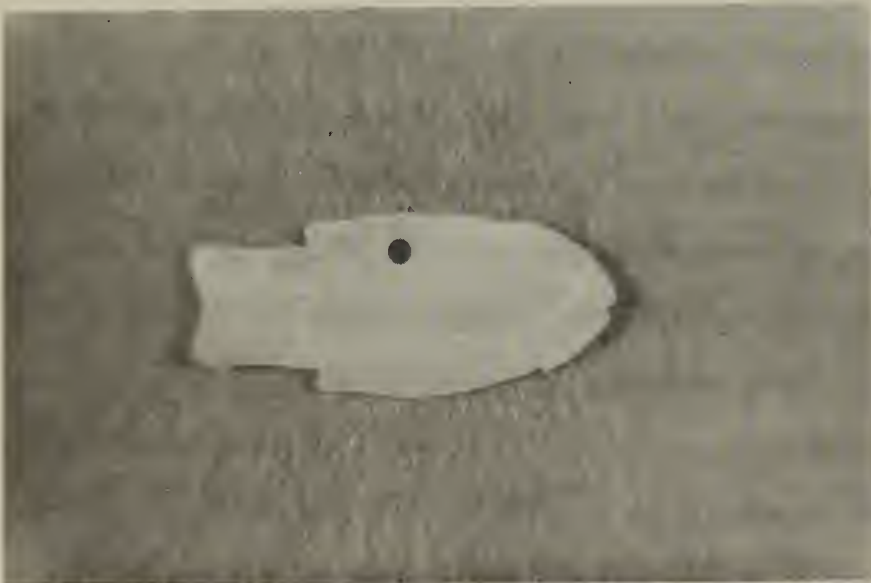
PHOTO 24. Shell Fish Pendant

Shell -- Fifty-five pieces of shell were recovered from this excavation. These shell pieces have not yet been analyzed, but there seem to be 4 olivella shells and the rest are bits and pieces of mother of pearl. Thirteen pieces of shell had drilled holes. Of these, many were pendants, but only four remained intact. One of these pendants is a fish (Photo 24).

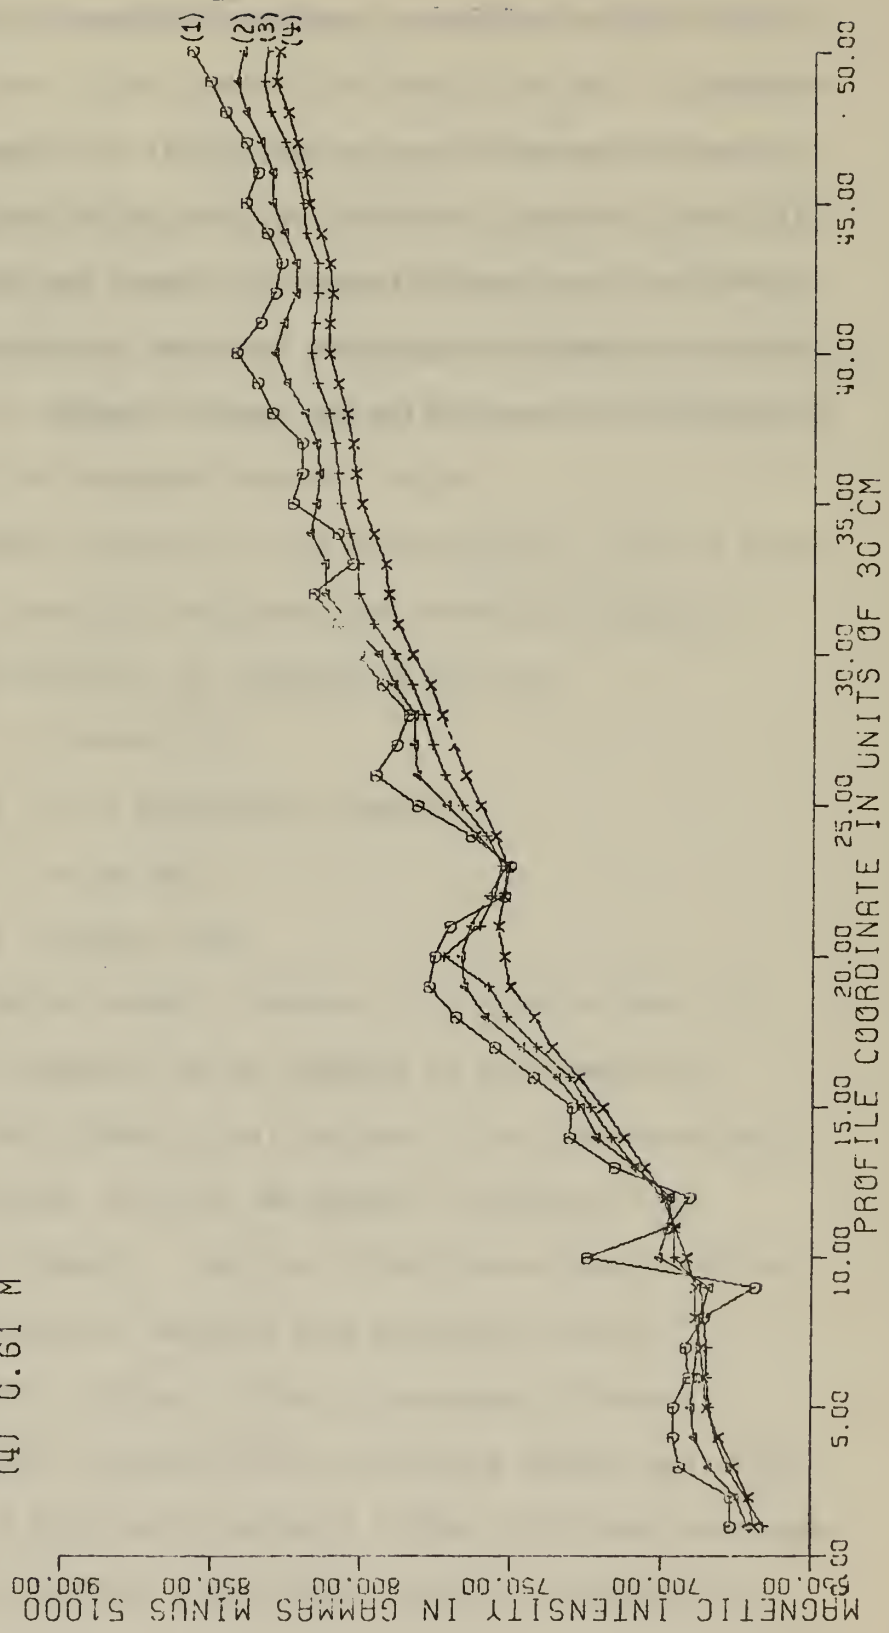
ILLUSTRATION 24
 THREE RIVERS OPTIMUM SENSOR HEIGHT DETERMINATION DATA
 MAGNETIC PROFILES USING 4 DIFFERENT SENSOR HEIGHTS
 (1) 0.15 M
 (2) 0.31 M
 (3) 0.46 M
 (4) 0.61 M

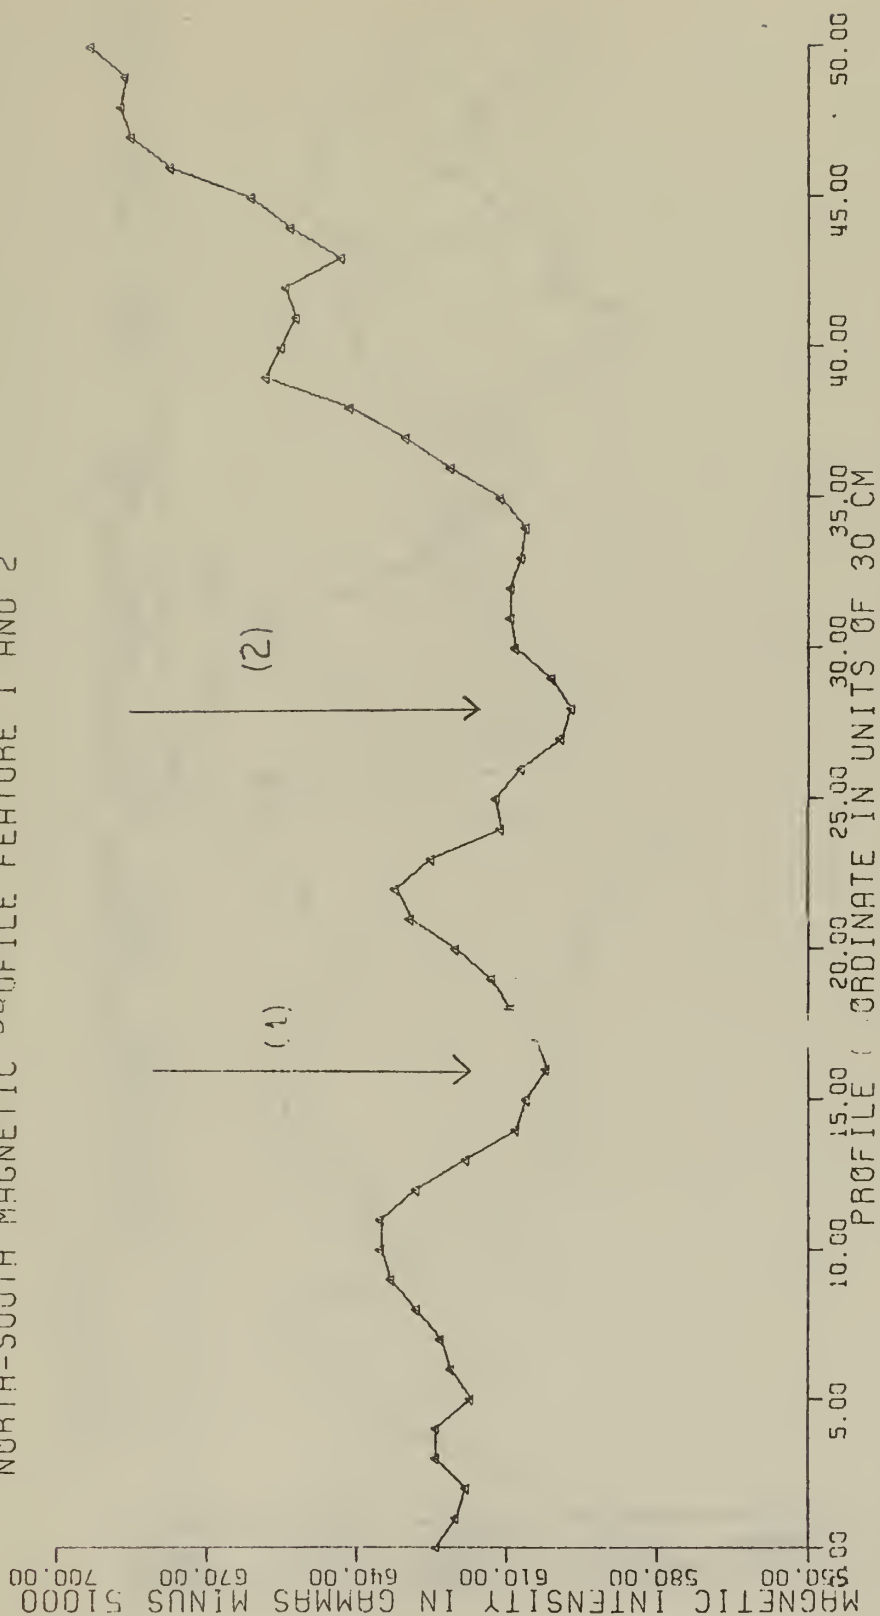
ILLUSTRATION 25
NORTH-SOUTH MAGNETIC PROFILE FEATURE 1 AND 2

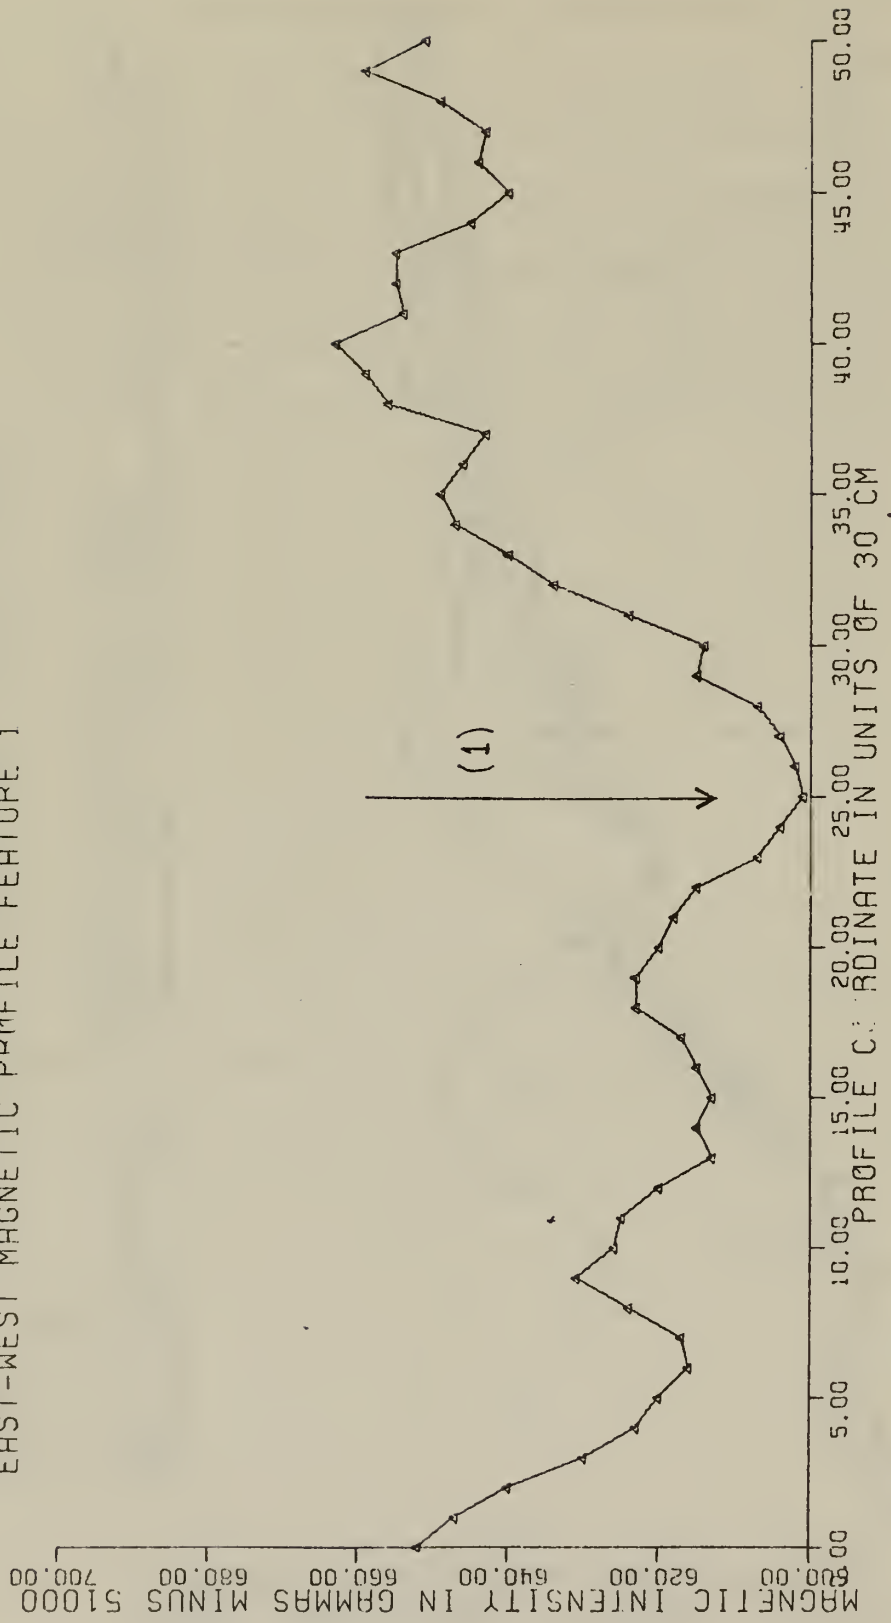
ILLUSTRATION 26
EAST-WEST MAGNETIC PROFILE FEATURE 1
